Evaluation Report  
Left turn calming pilot project  
City of Portland  
2020

## Summary: Results suggest turn calming enhances safety

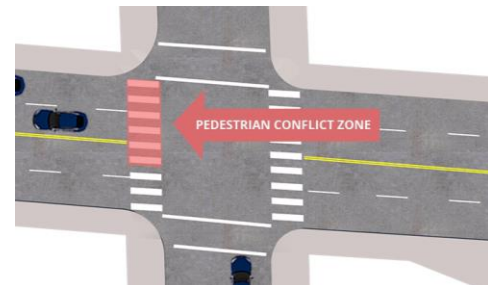
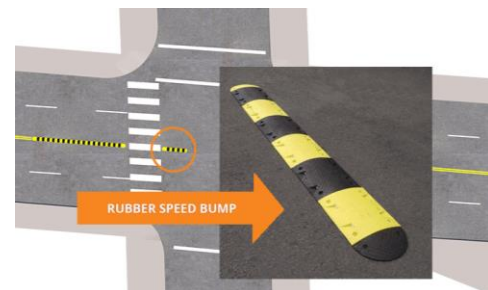
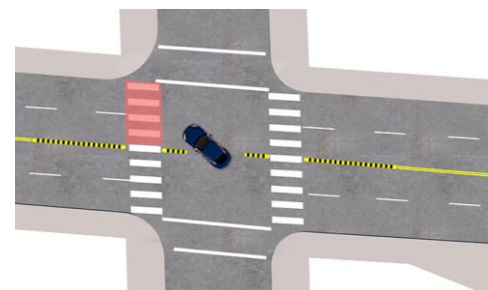
Figure 1. Basics of left turn calming

Left turn calming uses a combination of small, prefabricated rubber bumps (referred to simply as “bumps” in this report), delineator posts (“delineators”), and/or thermoplastic striping at signalized intersections to help prevent turning drivers from colliding with other road users, especially pedestrians (see Figure 1 at right).

1. Left-turning drivers pose a high risk to people in crosswalks.

2. Bumps “harden” the centerline on both sides of a crosswalk.

3. Left-turning drivers turn more slowly and at an angle that more directly faces the crosswalk, reducing crash risk.

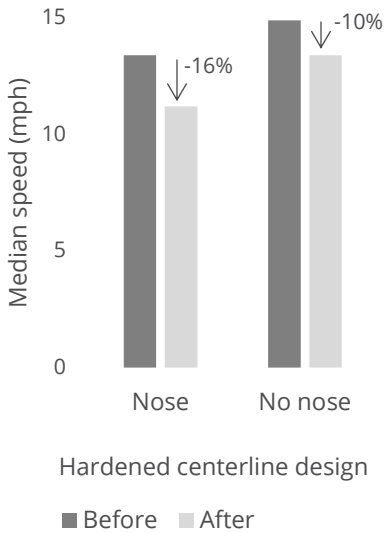
**Turning speed before and after turn calming, by design type**

Figure 2. Left turn calming with “noses” extending into the intersection are about 50 percent more effective at slowing speeds.

- Left turn calming consistently reduces turning speeds by modest but potentially significant amounts (median speed reduction of 13 percent, from an average median speed of 14.0 to 12.1 mph, across all locations with hardened centerlines).
- Hardened centerlines that include a “nose” that extends into the intersection are approximately 50 percent more effective at slowing speeds relative to centerlines without a nose (median speed reductions of 16 percent with noses compared to 10 percent without noses, see Figure 2).
- All left turn calming treatments nearly eliminate sharp turns in which drivers cross the centerline (reductions ranging from 82 to 100 percent, see Figure 3).

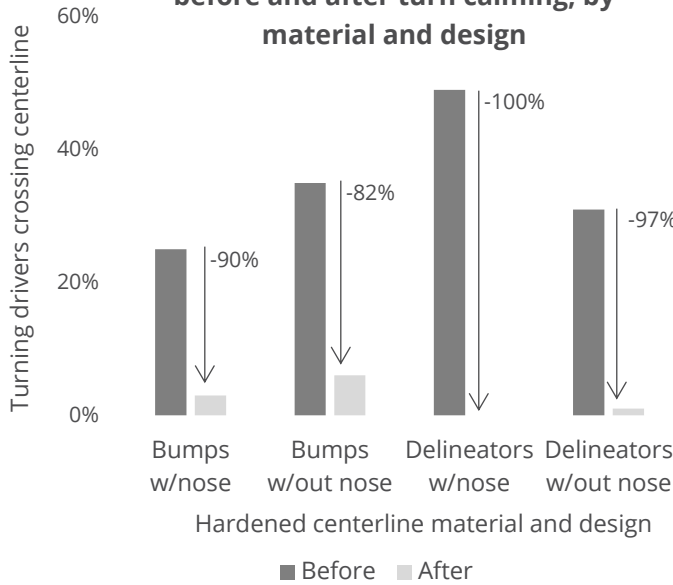
**Proportion of drivers crossing centerline before and after turn calming, by material and design**

Figure 3. Hardened centerlines of all types nearly eliminate sharp turns.

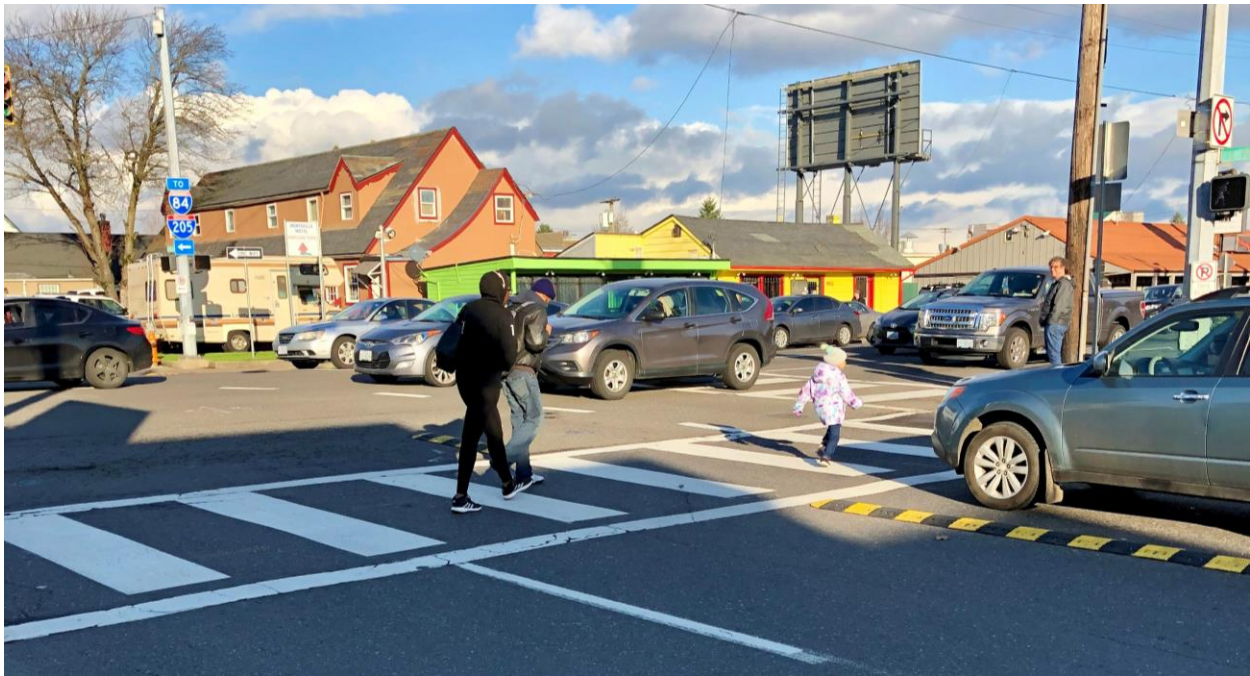
Figure 4. A hardened centerline using bumps with a nose at SE 99<sup>th</sup> Avenue & Stark Street, looking northeast, on December 23, 2019.

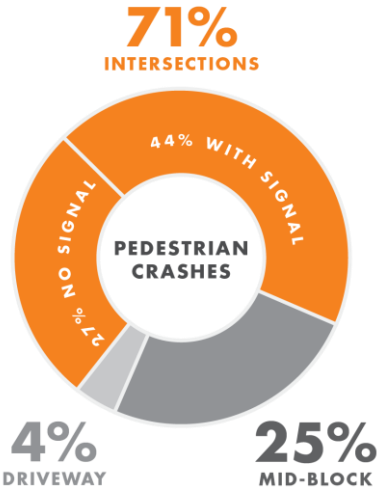
Figure 5. Most pedestrian crashes in Portland occur at intersections, especially where there are traffic signals. Data: 2006-15, Oregon Department of Transportation.

- Nearly half of pedestrian crashes occur at signalized intersections (see Figure 5).
- Nearly a quarter of pedestrian crashes involve left-turning drivers at signalized intersections (see Figure 6).

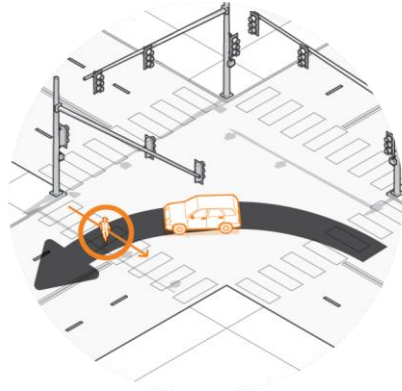
Figure 6. Left turns by people driving can be especially risky for people in crosswalks.

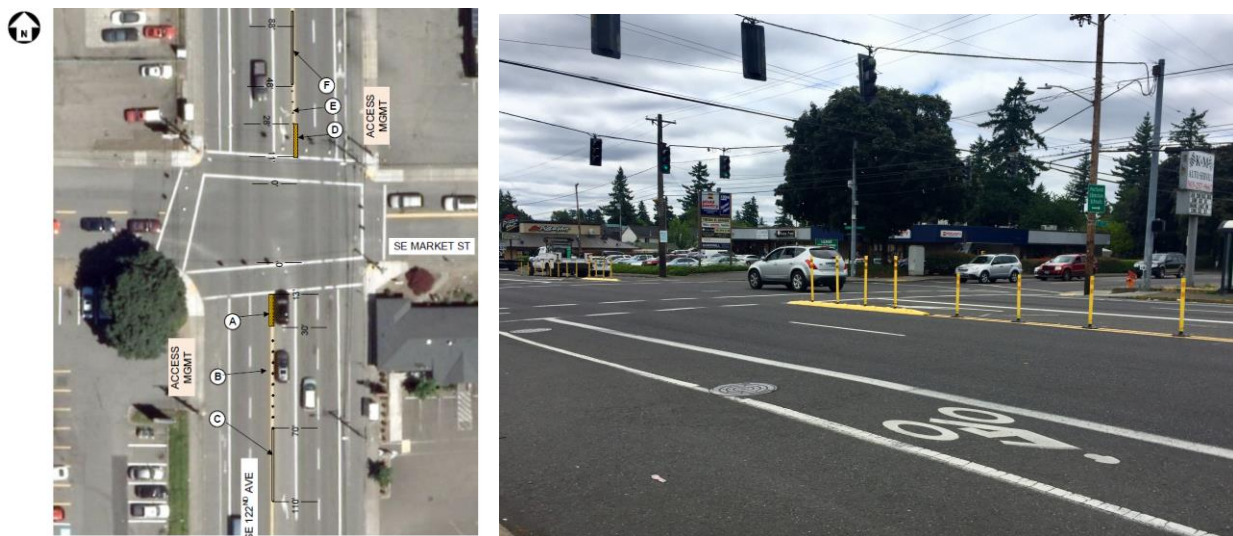
Figure 7. A PBOT work order (left) shows a top-down view of a hardened centerline using plastic curbing and delineators (labeled "A") that is extended to support access management (B) on the south leg of SE 122<sup>nd</sup> Ave. & Market St. The photo (right) shows the installation looking north/northeast.

**Hardened centerlines:** Most pilot project intersections (35 out of 42) included a "hardened centerline" (see Figure 7). This is a section of centerline leading up to an intersection equipped with bumps (24 intersections) and/or raised plastic curbing with delineators (11 intersections).

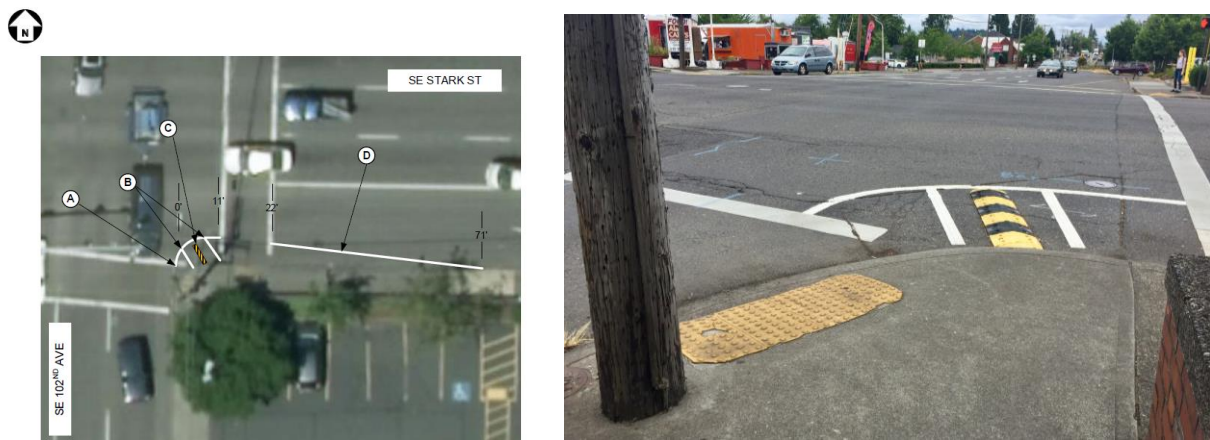
Figure 9. A PBOT work order (left) shows a top-down view of a wedge with thermoplastic striping on the southeast corner of SE 102<sup>nd</sup> Ave. & Stark St. The photo (right) shows the installation looking north/northwest.

**“Wedge” at corners:** Some intersections (11 out of 42) received a “wedge” at corners (see Figure 9). Wedges are similar to curb extensions, but are located outside of crosswalks and can be driven over if necessary. Most wedges use only bumps and striping. They can be used to slow left- or right-turning drivers.

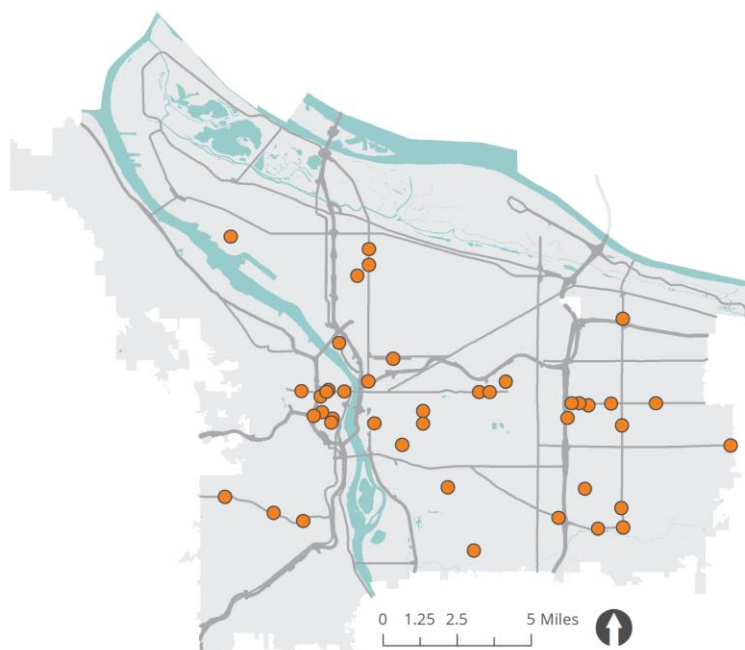
Figure 10. Left turn calming pilot locations in Portland.

Left turn calming is a flexible treatment that can fit in a variety of intersection types. Figure 10 shows the locations of the 42 intersections piloted for left turn calming,

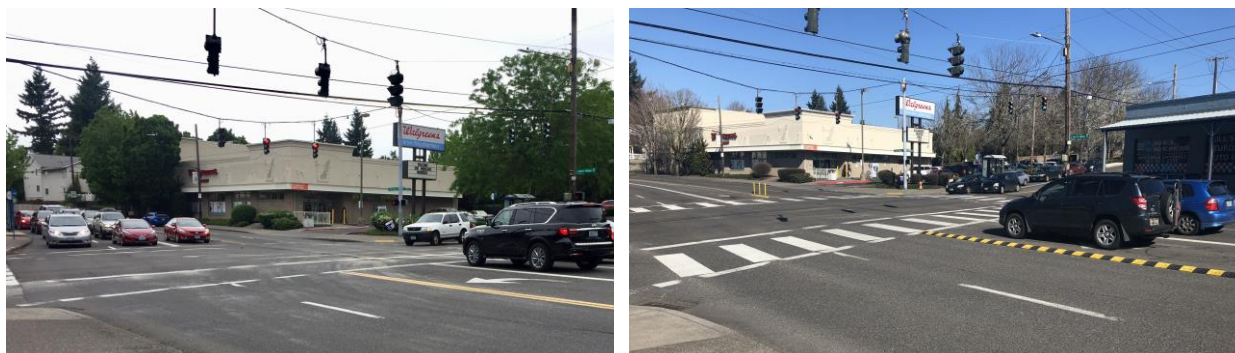
Figure 11. PBOT installed high-visibility crosswalks concurrent with left turn calming, including at SE Holgate & Chávez boulevards, pictured on May 20, 2019 (left) and on March 9, 2020, afterward.

- **No control group:** The lack of a control group increases the probability that any results detected in the evaluation stem from factors other than the left turn calming treatment. For example, PBOT concurrently installed high visibility crosswalk markings at most left turn calming locations, introducing a potentially confounding factor in the analysis (see Figure 11).
- **Small samples:** Treatment groups consisted of as little as two locations, increasing the chance that evaluation results do not accurately represent the treatment's effects.
- **Uncertain speed measurements:** Turning speeds could be more accurately assessed through video analysis, or a similarly rigorous method, rather than by use of a handheld Lidar device.

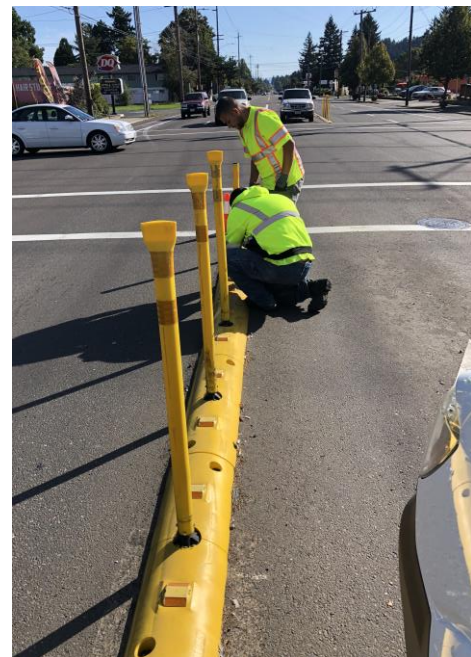
**Figure 12.** PBOT staff replace six displaced delineators at SE Division Street & 174<sup>th</sup> Avenue on October 2, 2019.

Only locations using delineators required maintenance during the pilot, except for one location where bump installation damaged signal detection loops.

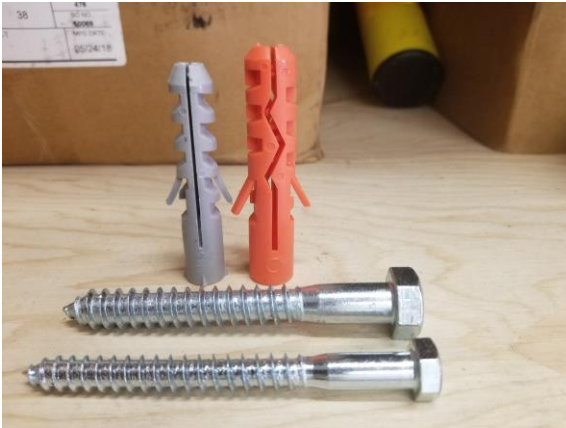
Figure 13. The orange sleeves and longer (4") bolts work better than the grey sleeves and shorter bolts that are included with the bumps.

- **Bumps should not be installed with included hardware:** Installation hardware included with the bumps uses plastic sleeves that are “small, brittle and break when hammered in.” Staff also noted that the small drill bit was “binding up” and there was an overheating issue. After several installations, MO staff switched to using anchor bolt kits that come with Tuff Posts from Impact Recovery Systems, which are a regularly stocked item at PBOT and use the same drill bit for surface mounted pipe (see Figure 13). MO staff indicate this hardware has worked well. ([Appendix E](#) documents a similar experience in New York. [Appendix F](#) provides specifications for the Impact Recovery Systems anchor kit.)

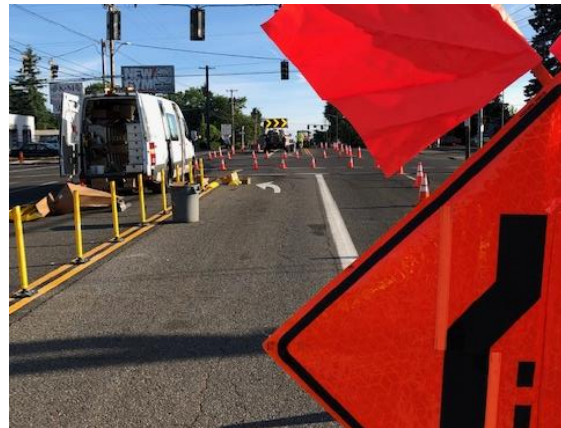
Figure 14. High-volume intersections such as SE 122nd Avenue & Market Street can require significant traffic control.

- **Early morning hours are ideal for installation:** Many left turn calming locations are at high-volume intersections that can require significant traffic control to protect MO staff during installation (see Figure 14). Lower traffic volumes during early morning hours

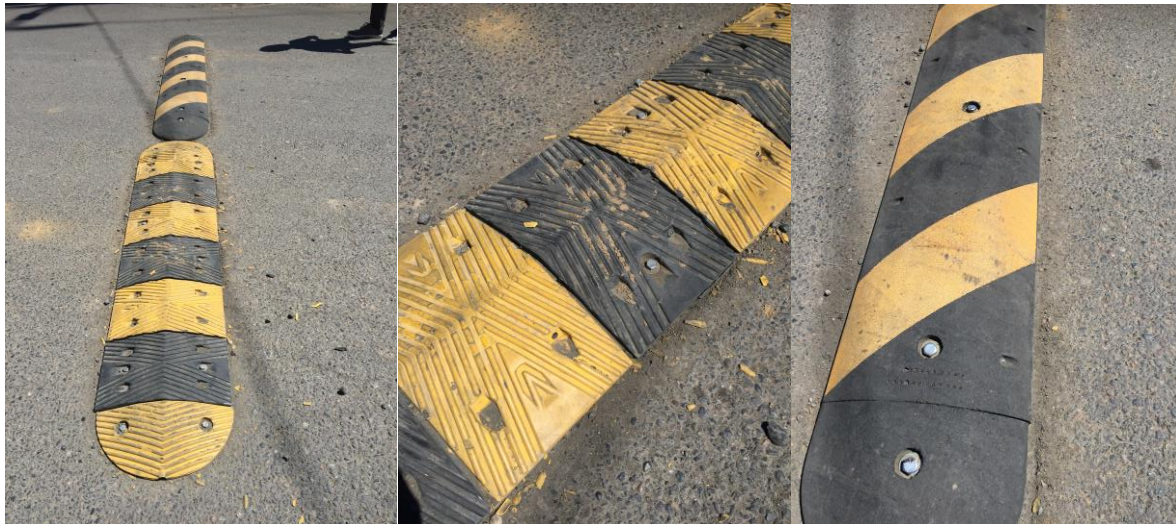
## Appendix A: Rubber speed bump product comparison

The TreeTop Products bump (left photo at front and middle photo) and Checkers bump installed for testing at a PBOT parking lot, pictured after approximately two months of use.

Products	<b>TreeTop Products Premium Recycled Rubber Speed Bump compared to Checkers Easy Rider Rubber Speed Bump</b>
<b>Walking</b>	Both bumps were walked on in dry and wet conditions during daytime. The Checkers bump was comparable to the TreeTop bump in dry conditions, but felt considerably more slippery in wet conditions. The TreeTop bump felt safer on foot overall.
<b>Biking</b>	A steel-frame bicycle with standard road tires was ridden over both bumps at various angles in dry and wet conditions during daytime. The Checkers bump felt significantly more jarring relative to the TreeTop bump during all approaches. Slipping did not occur on either bump at relatively low speeds, even when impacting the bumps at an angle and in wet conditions. Slipping could be an issue at higher speeds, but the more likely hazard may stem from momentary loss of control following impact with either bump. Both bumps were unpleasant to experience on a bicycle, but the Checkers bump was more jarring and may be more likely to present a hazard to people riding bikes. The TreeTop bump felt safer overall on a bicycle.

<b>Motorcycle</b>	<p>Both speed bumps were tested to ensure that a motorcyclist can safely maneuver over them at various angles without slipping or crashing. The motorcyclist rode a 2015 Yamaha SR400 over the bumps multiple times roughly between 10 and 20 mph in dry and wet conditions during daytime. When approaching perpendicular to the speed bumps, neither brand felt slippery but the Checkers bump felt a bit more jarring than the TreeTop bump, particularly at higher speeds. When approaching the bumps at an angle, the TreeTop bump appeared to be more slip resistant and the Checkers bump caused the wheel to slip a bit when wet. In the rider's opinion, the TreeTop product felt safer on a motorcycle.</p>
<b>Driving</b>	<p>Both bumps were driven over using a sedan and SUV at various angles in dry and wet conditions during daytime. No significant differences were noted. Both bumps create a noticeable impact within the vehicles, but the impact is significantly dampened by vehicle suspensions. The bumps seem to be equally suitable.</p>

<b>Additional comments</b>	<p>The cat's eye reflectors in the TreeTop bump showed signs of accumulating dirt, which may reduce the visibility of the bump in dark conditions.</p> <p>The TreeTop bump's yellow coloring appears to be embedded in the rubber; in contrast, the Checkers bump has yellow tape, which may wear out relatively quickly and degrade visibility.</p> <p>The Checkers bump has yellow tape coated with glass beads, which may be a source of reduced traction noted during testing.</p> <p>Large maintenance trucks and equipment drove over the bumps while we were observing. One operator noted that they were "soft," and we observed the bumps deflecting when heavy vehicles drove over them.</p>
